New LN₂ Heat Exchanger for HEUB Helium Refrigerator

2/11/04 K. C.

Photos on HEUB E-1 LN2 Heat Exchanger Removal And Replacement

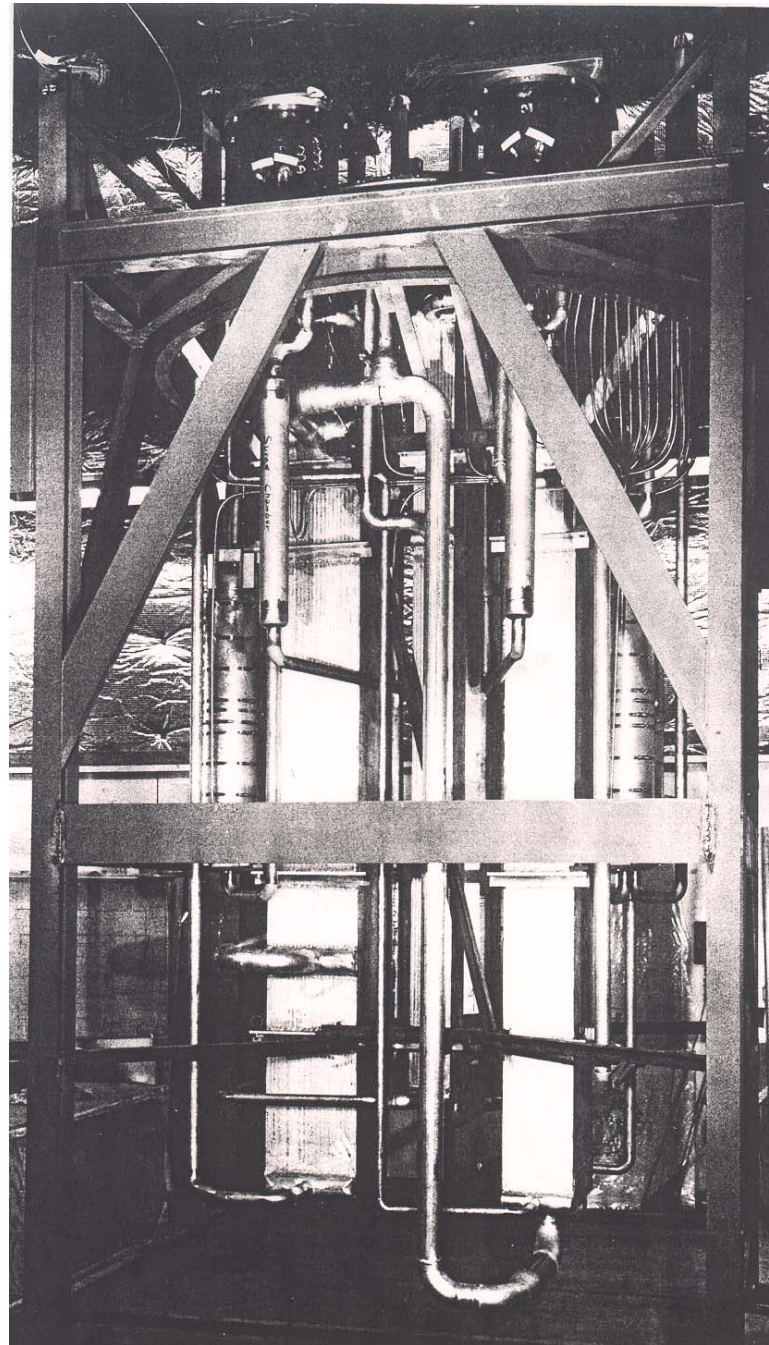
Front view of HEUB
cold box, LN₂ HX is
on the exchanger on
the right

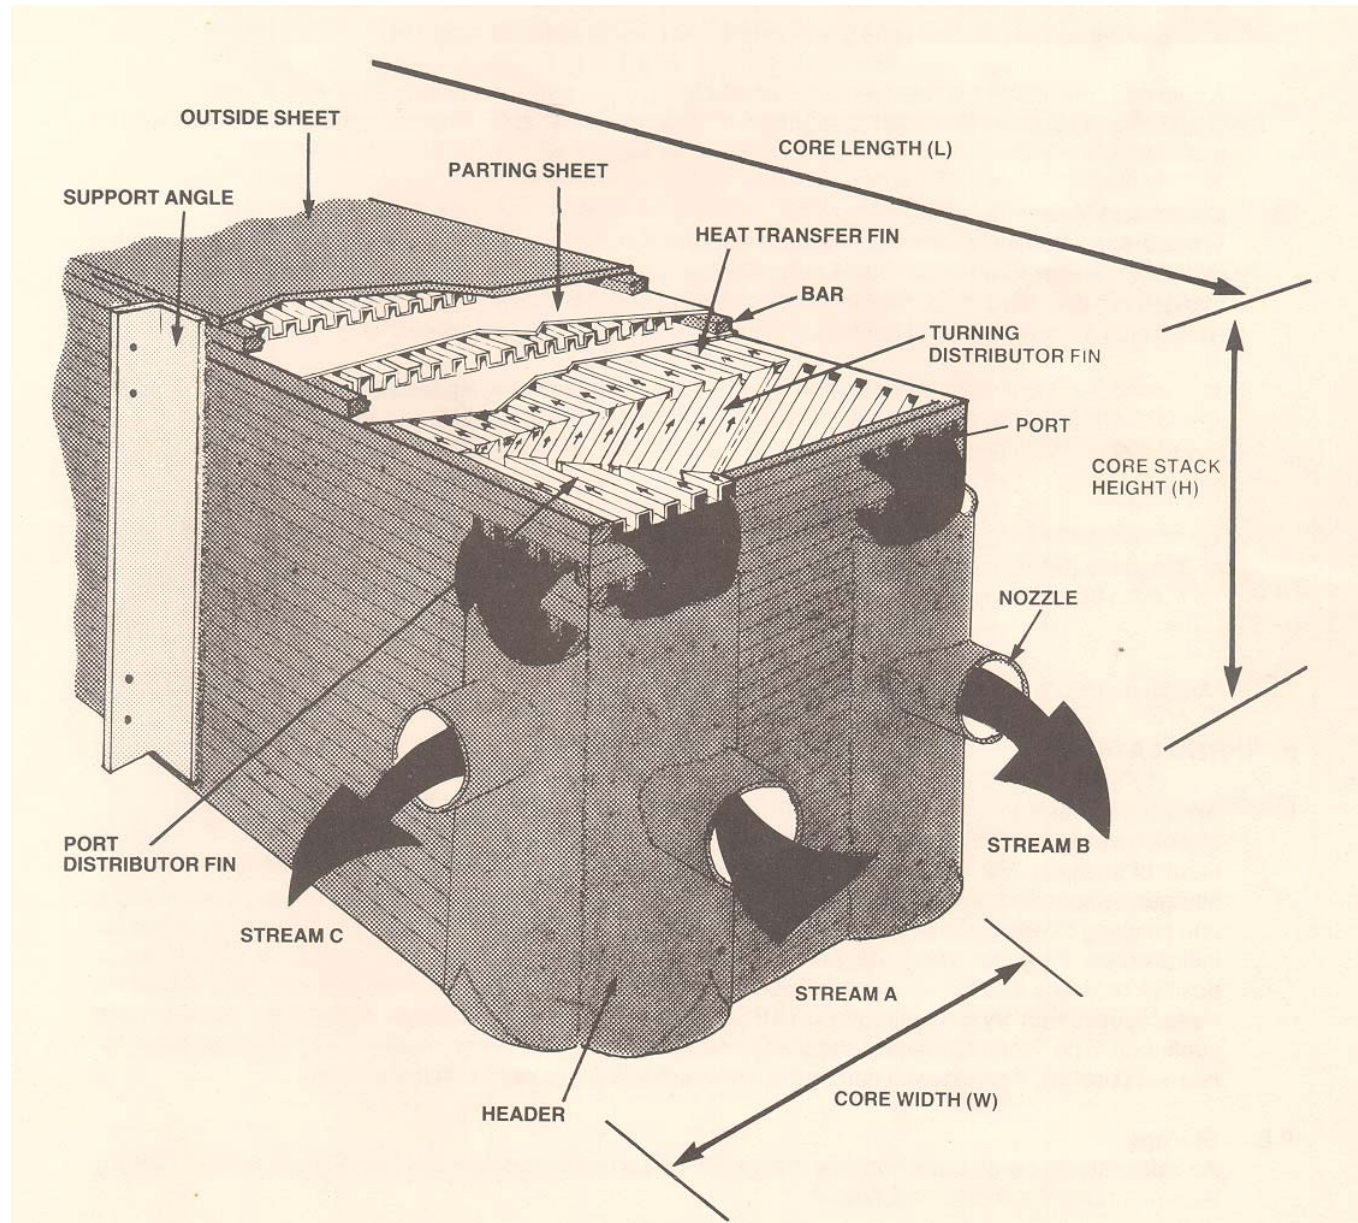
Basic Components of a Brazed Aluminum HX (Cutaway)

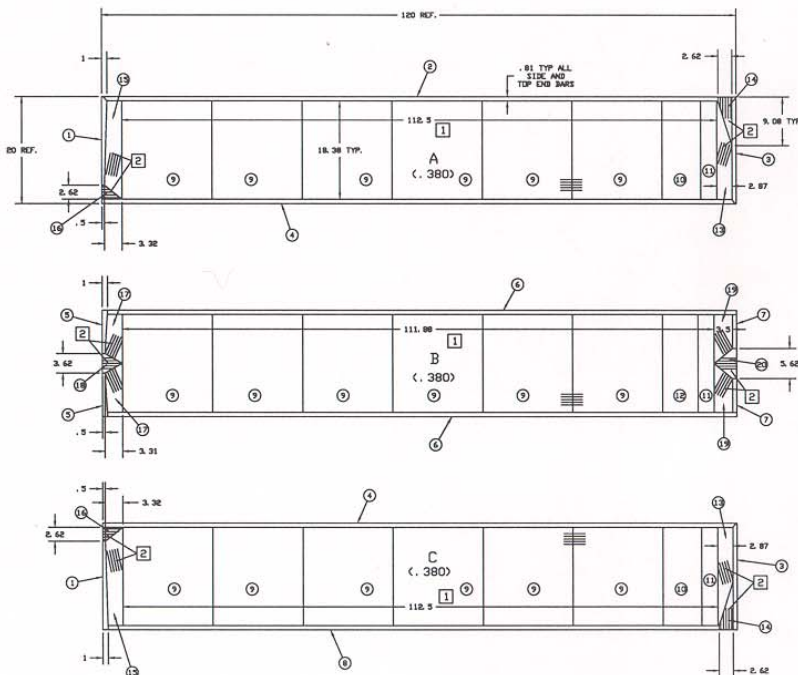
New LN₂ HX - Drawing 2

1	TYPE: 1/8 SERR MATL: .010 THK	FPI: 18.0 DIE: CT-7162
2	TYPE: PLAIN MATL: .016 THK	FPI: 8.0 DIE: CT-7221

PARTING SHEETS ARE .039 THK. (#020)
OUTSIDE SHEETS ARE .250 THK.
STACKED HEIGHT = 11.37
BRAZED HEIGHT = 11.26
CORE BLOCK WEIGHT = 1000 LBS.

OPERATIONAL
TOP END

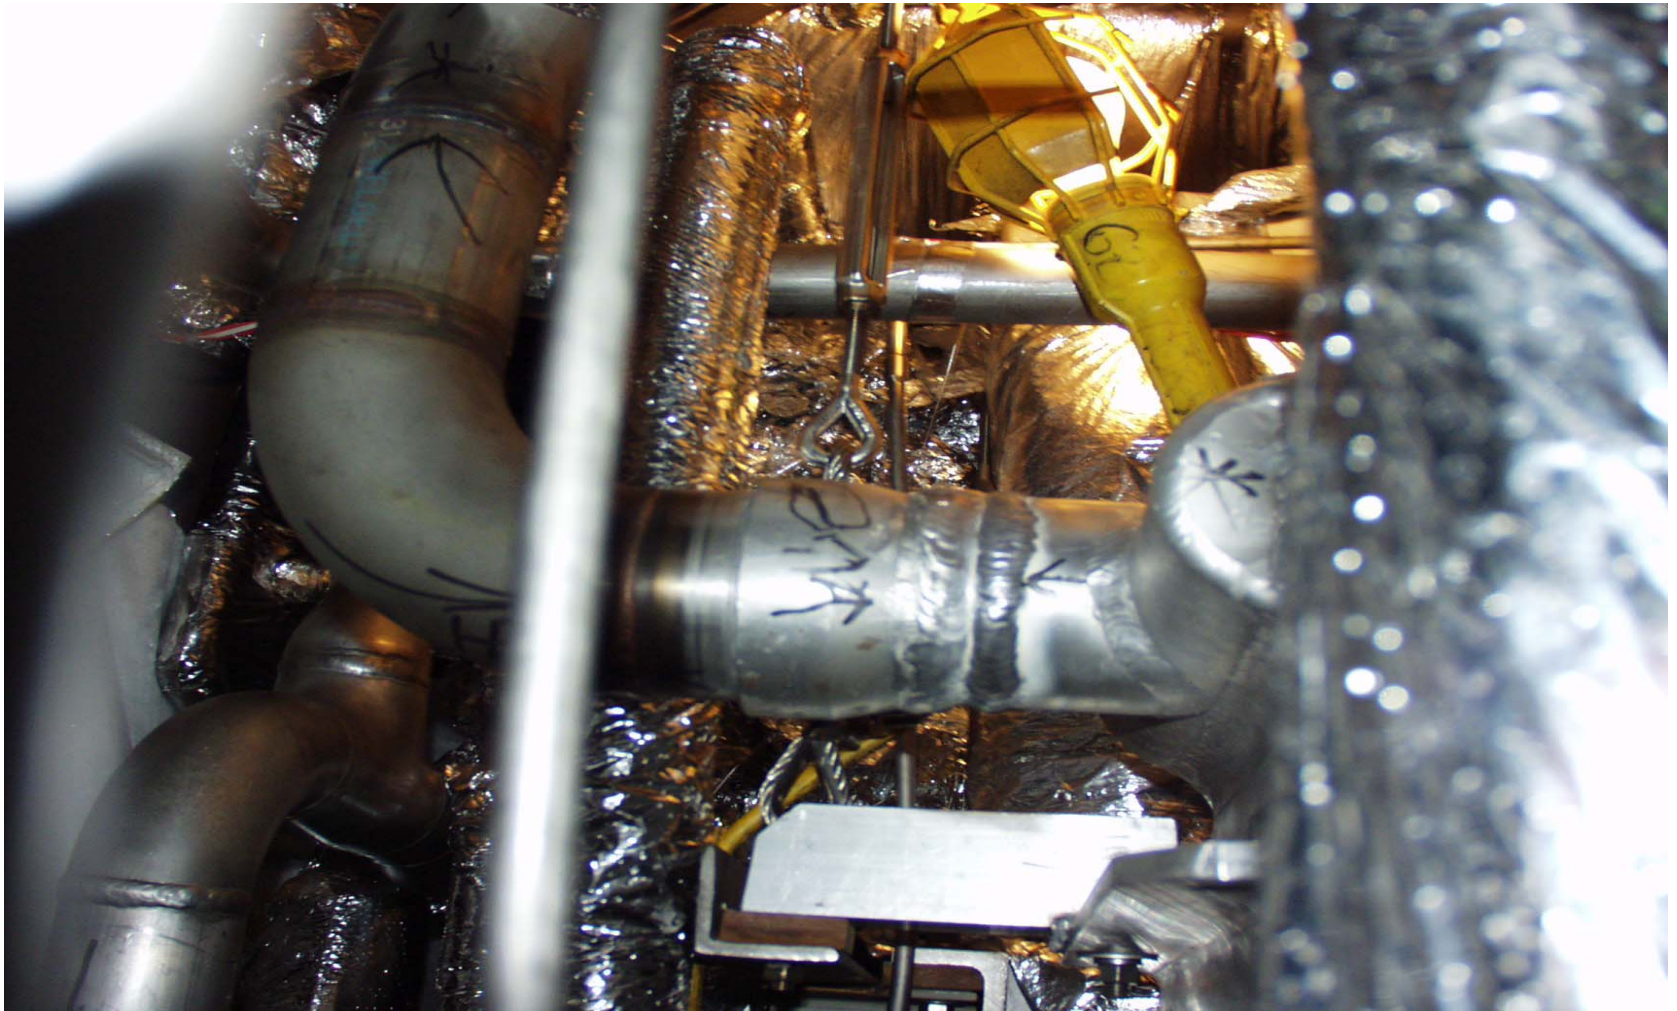
A.1) Heat exchanger high pressure inlet.

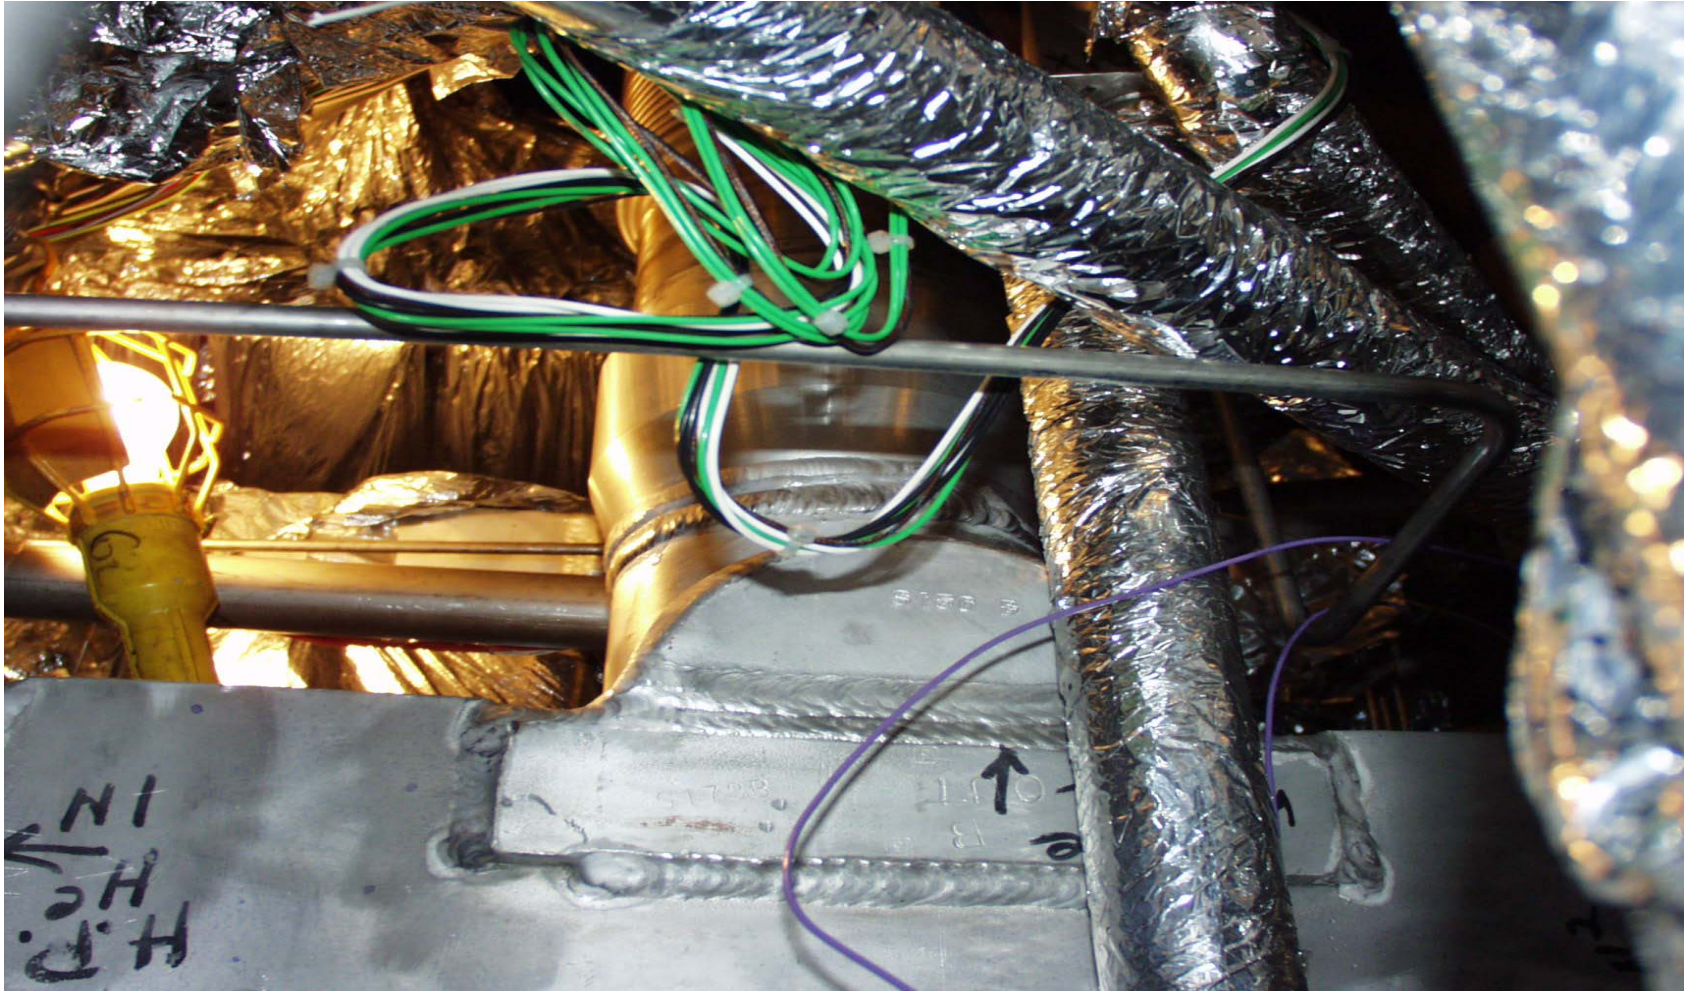
A.2) Heat exchanger low pressure outlet.

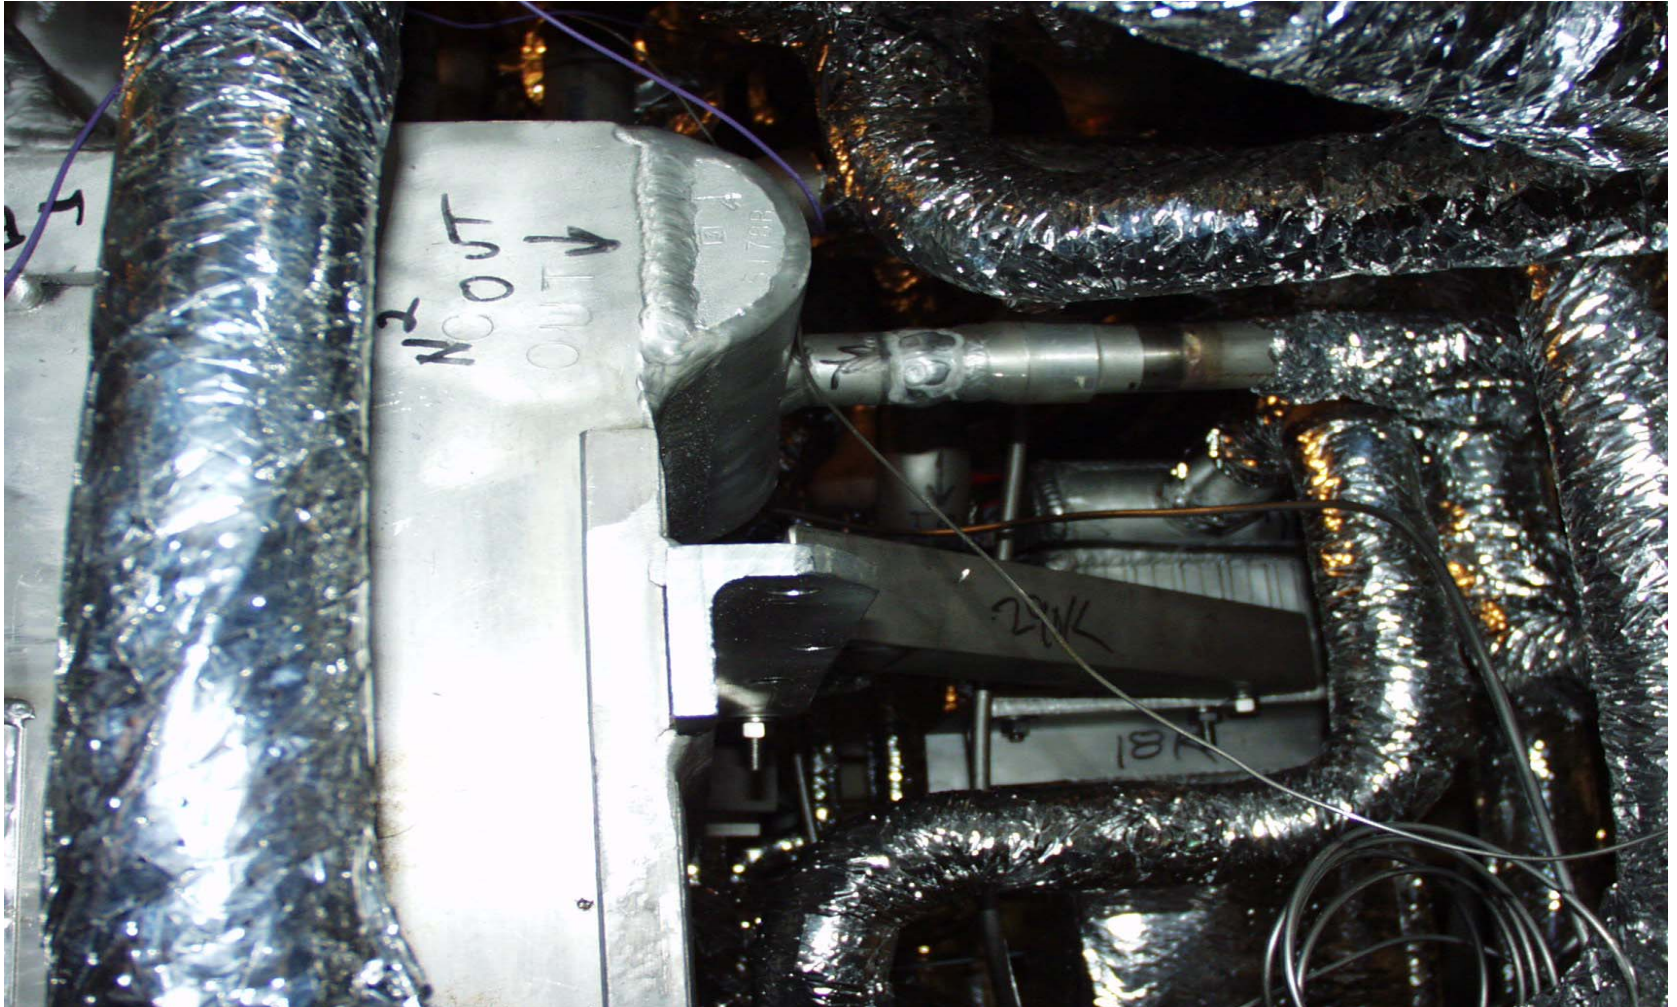
A.3) Heat exchanger LN2 outlet.

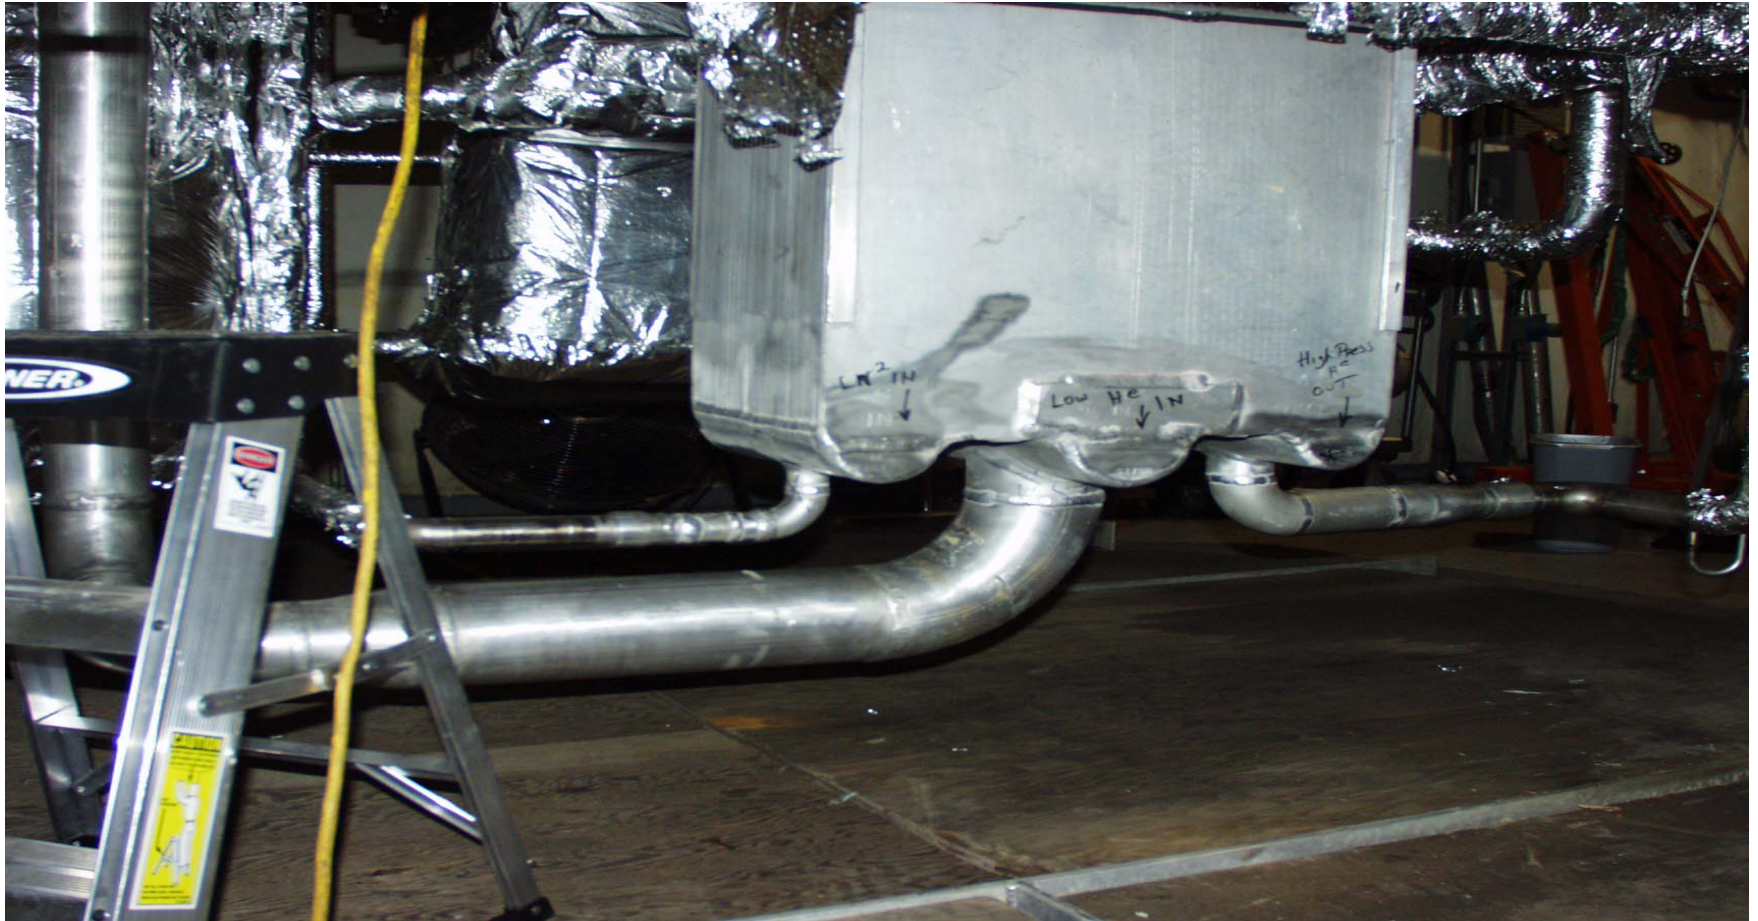
A.4) Heat exchanger high pressure outlet, low pressure inlet and LN2 inlet.

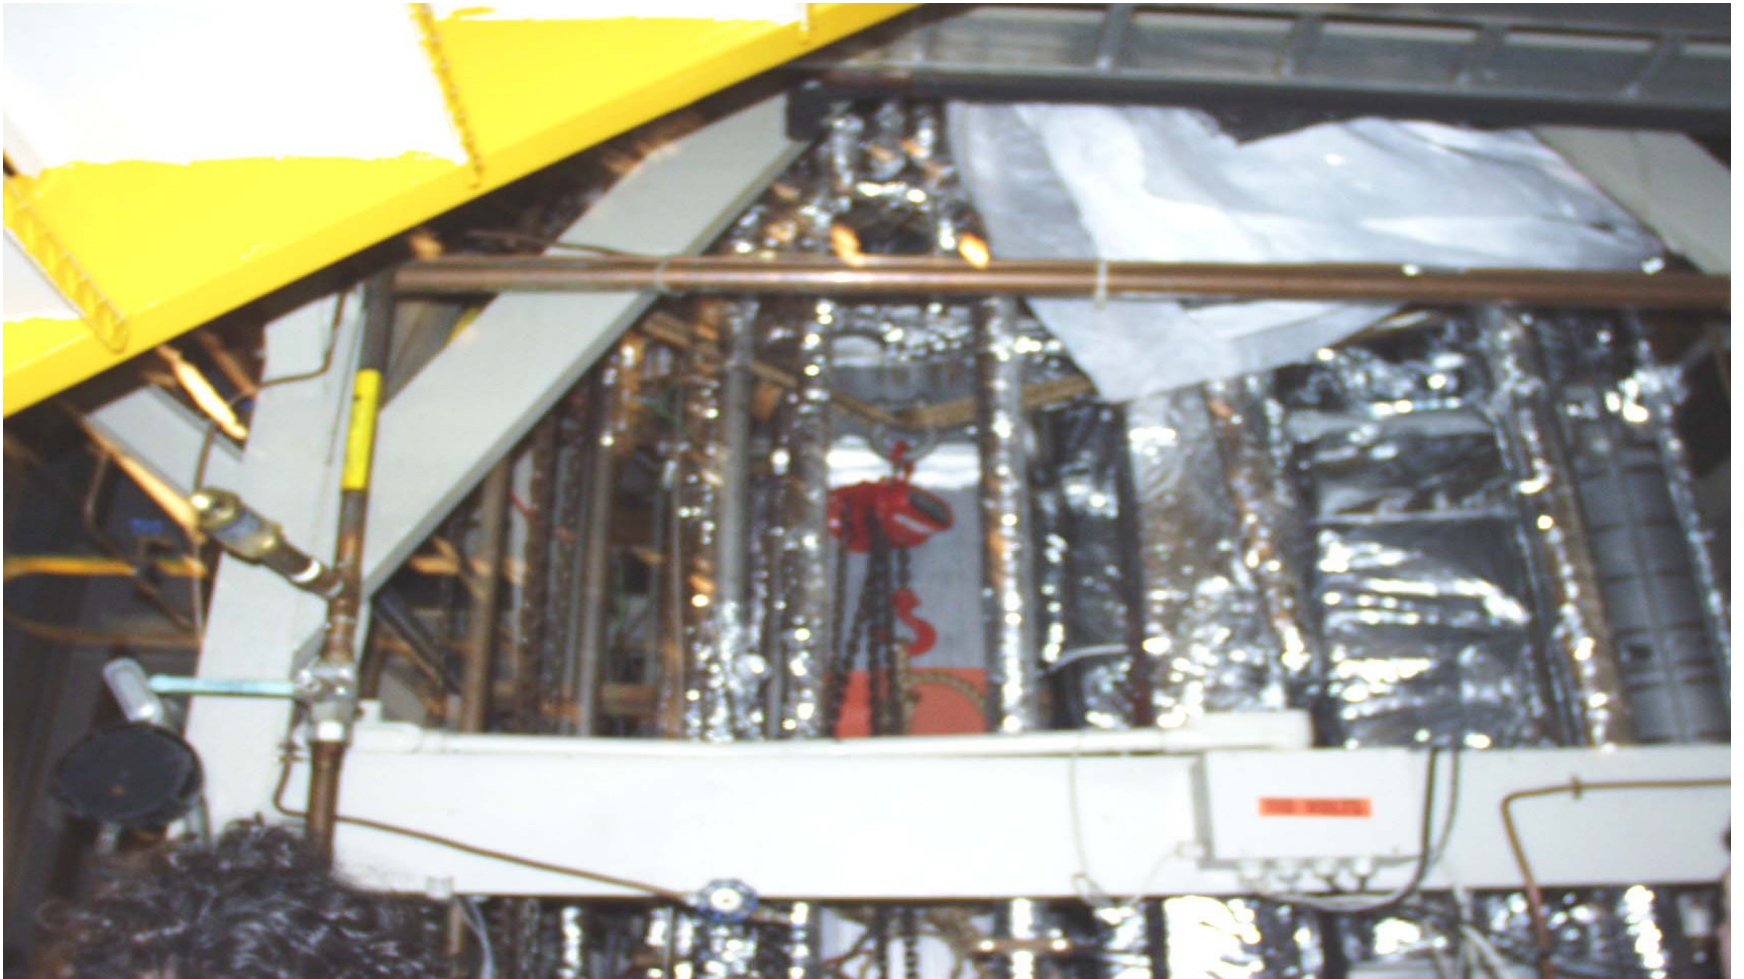
B.1) RIGGING

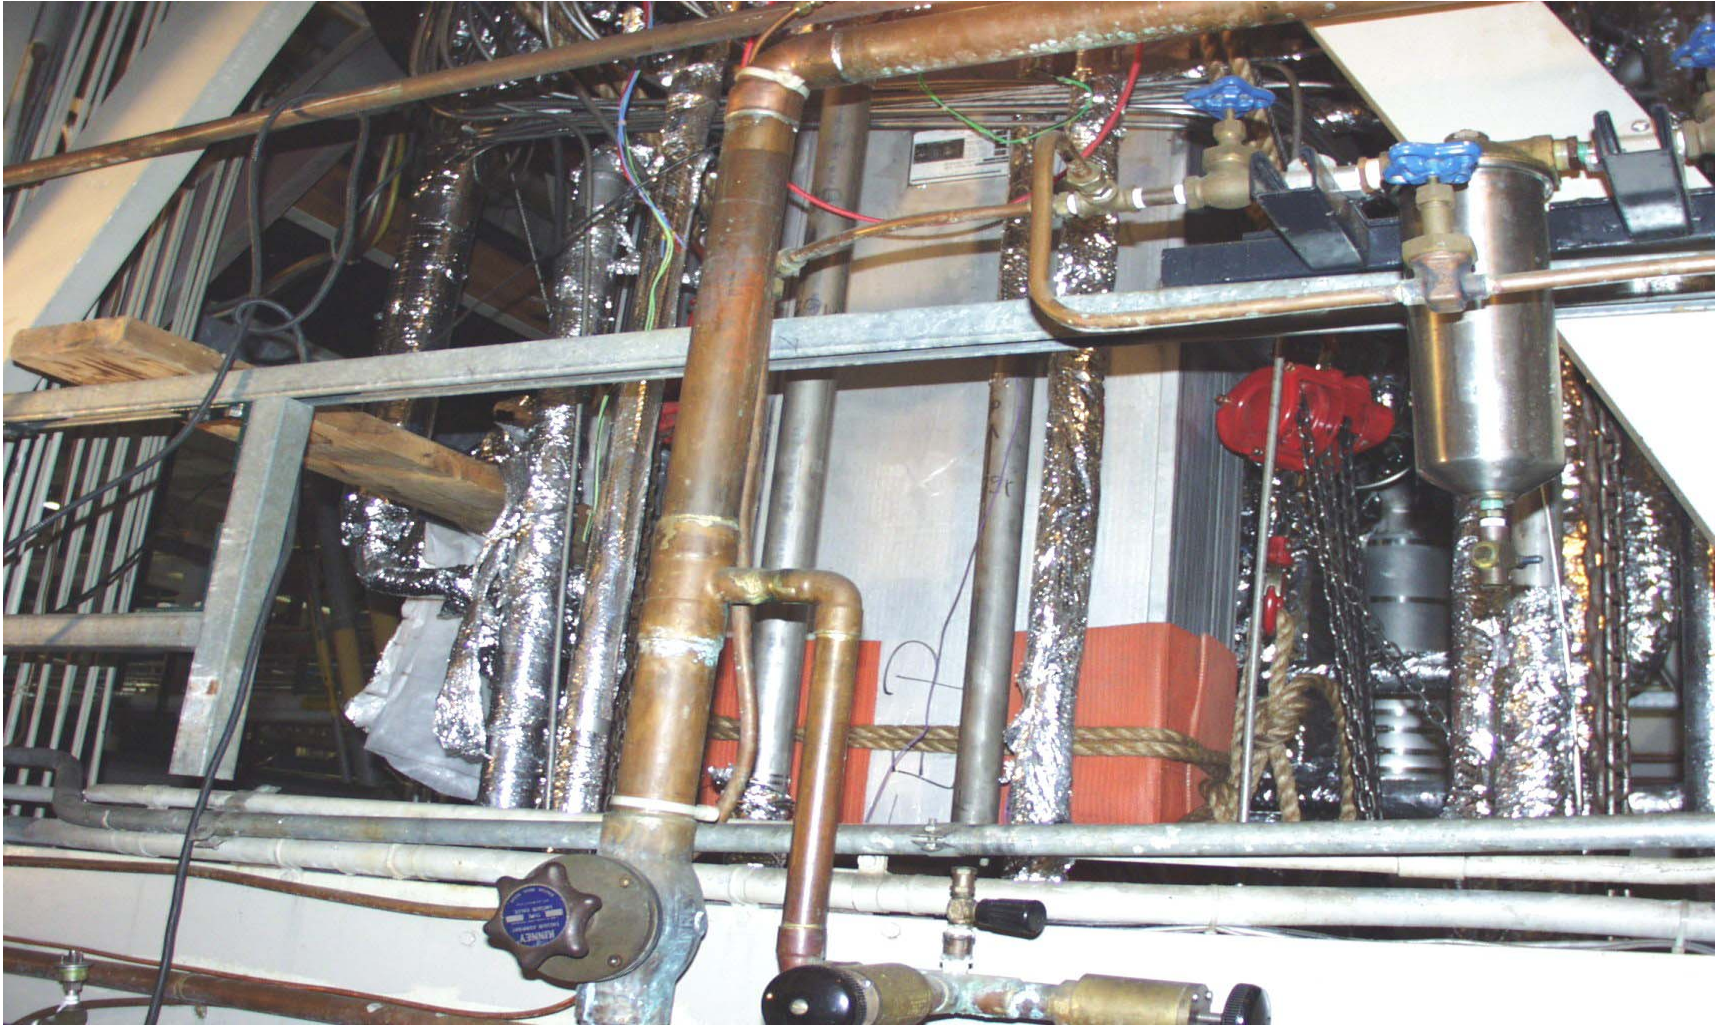
B.2) Heat Exchanger Rigging

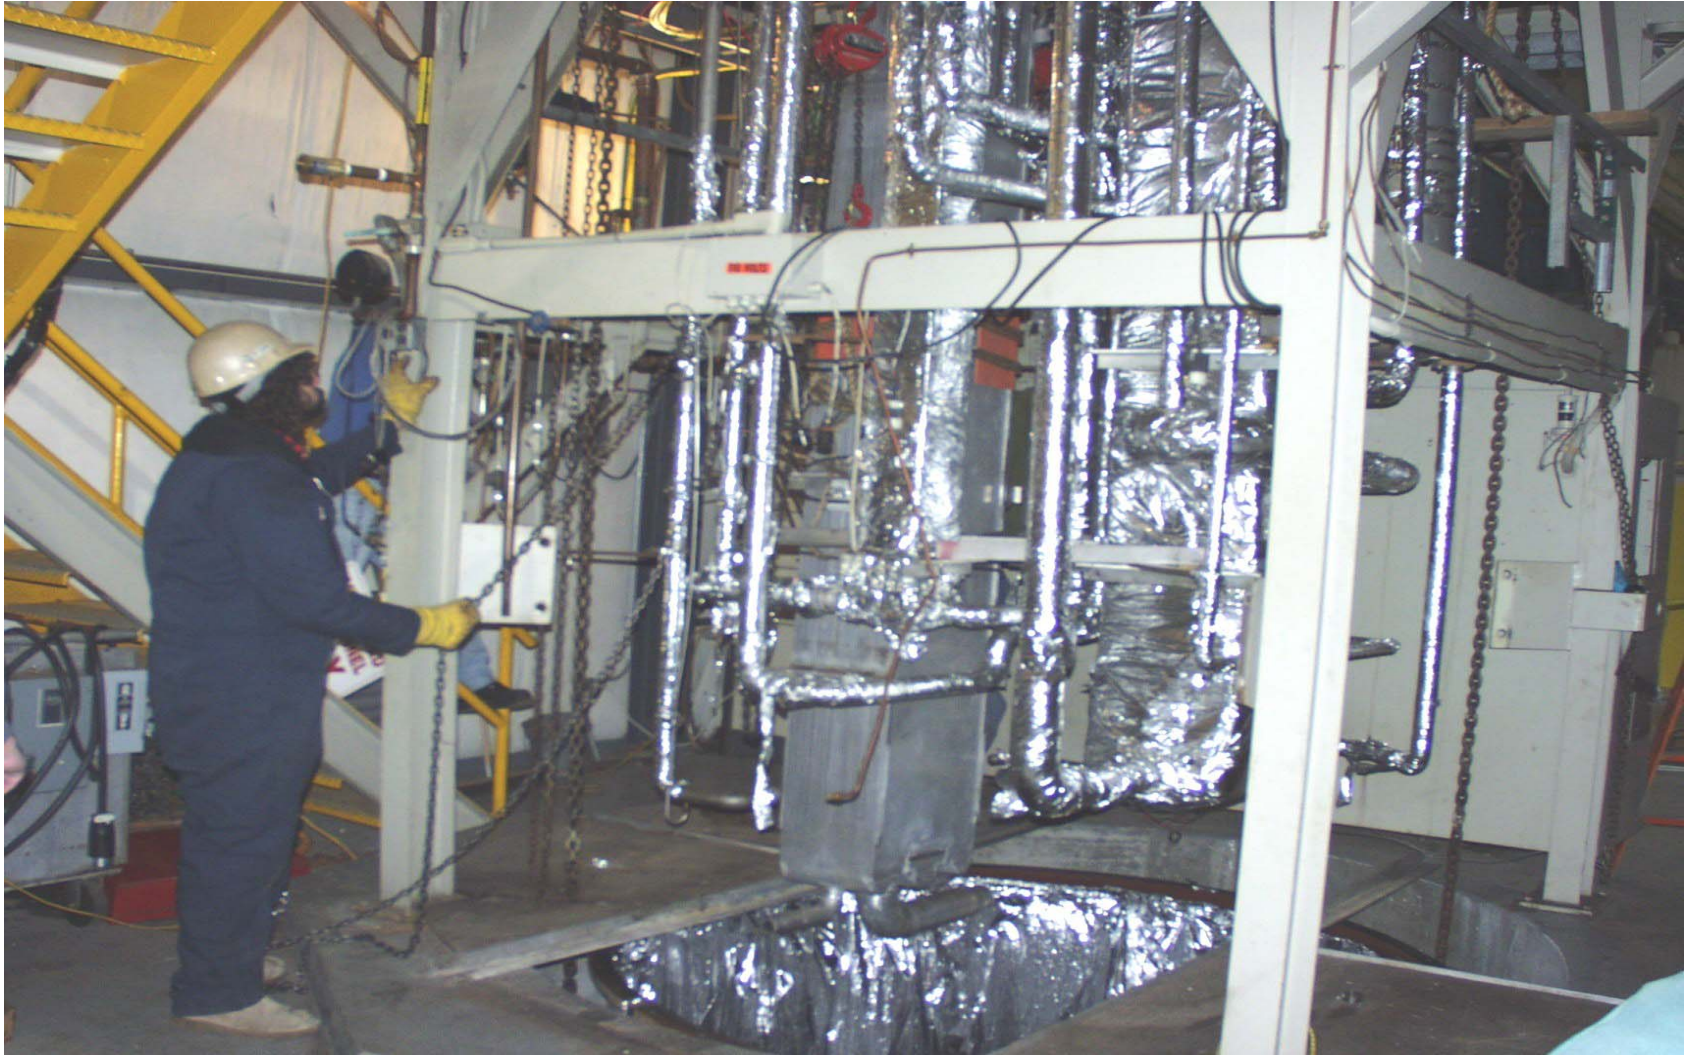
C.1) Heat Exchanger removal.

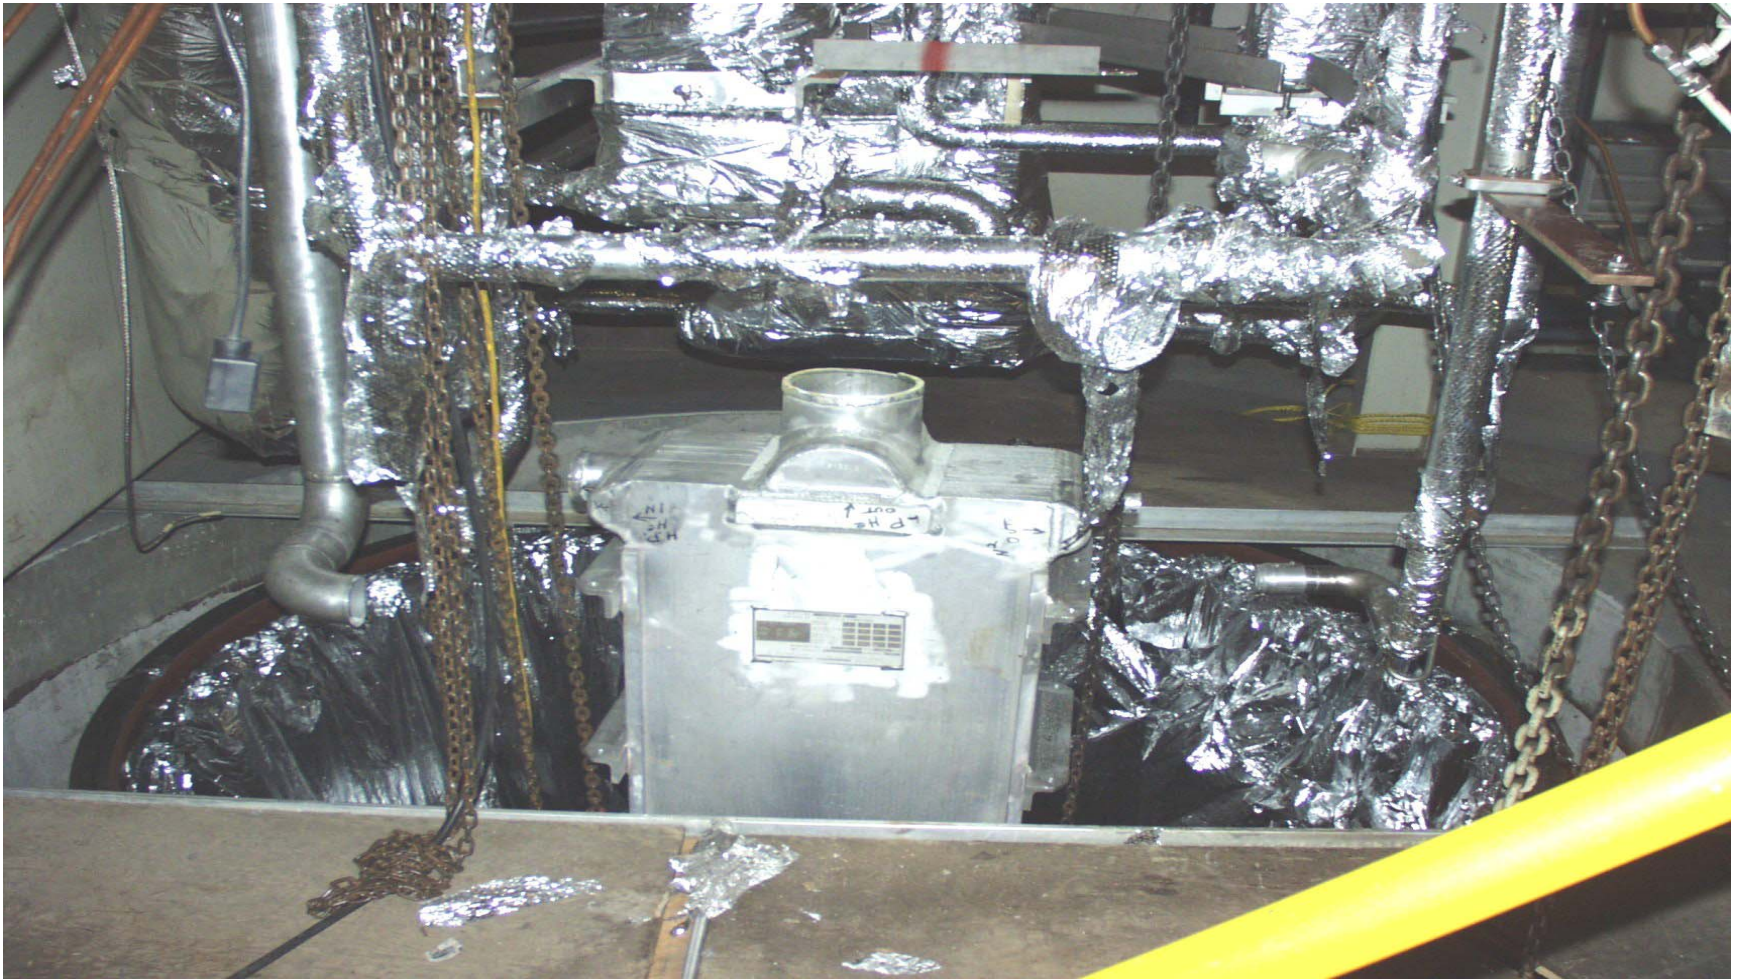
C.2) Heat Exchanger lowering

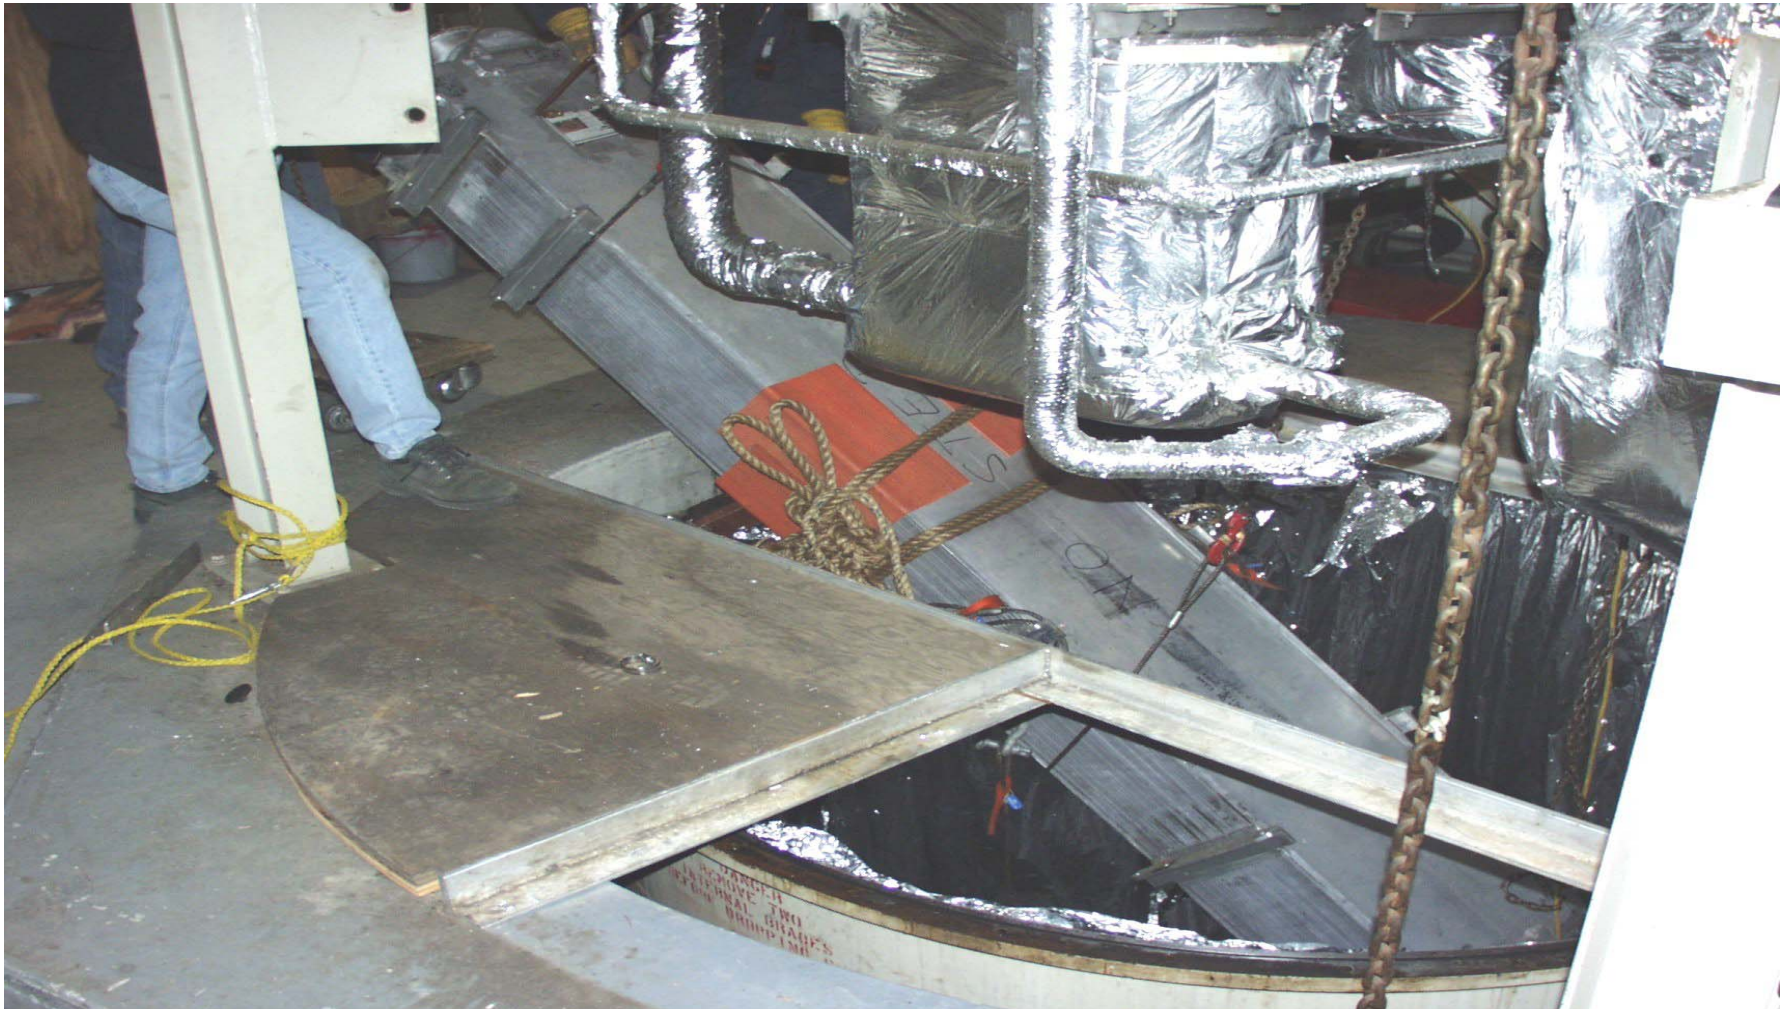
C.3) Heat Exchanger Removal From vacuum Can

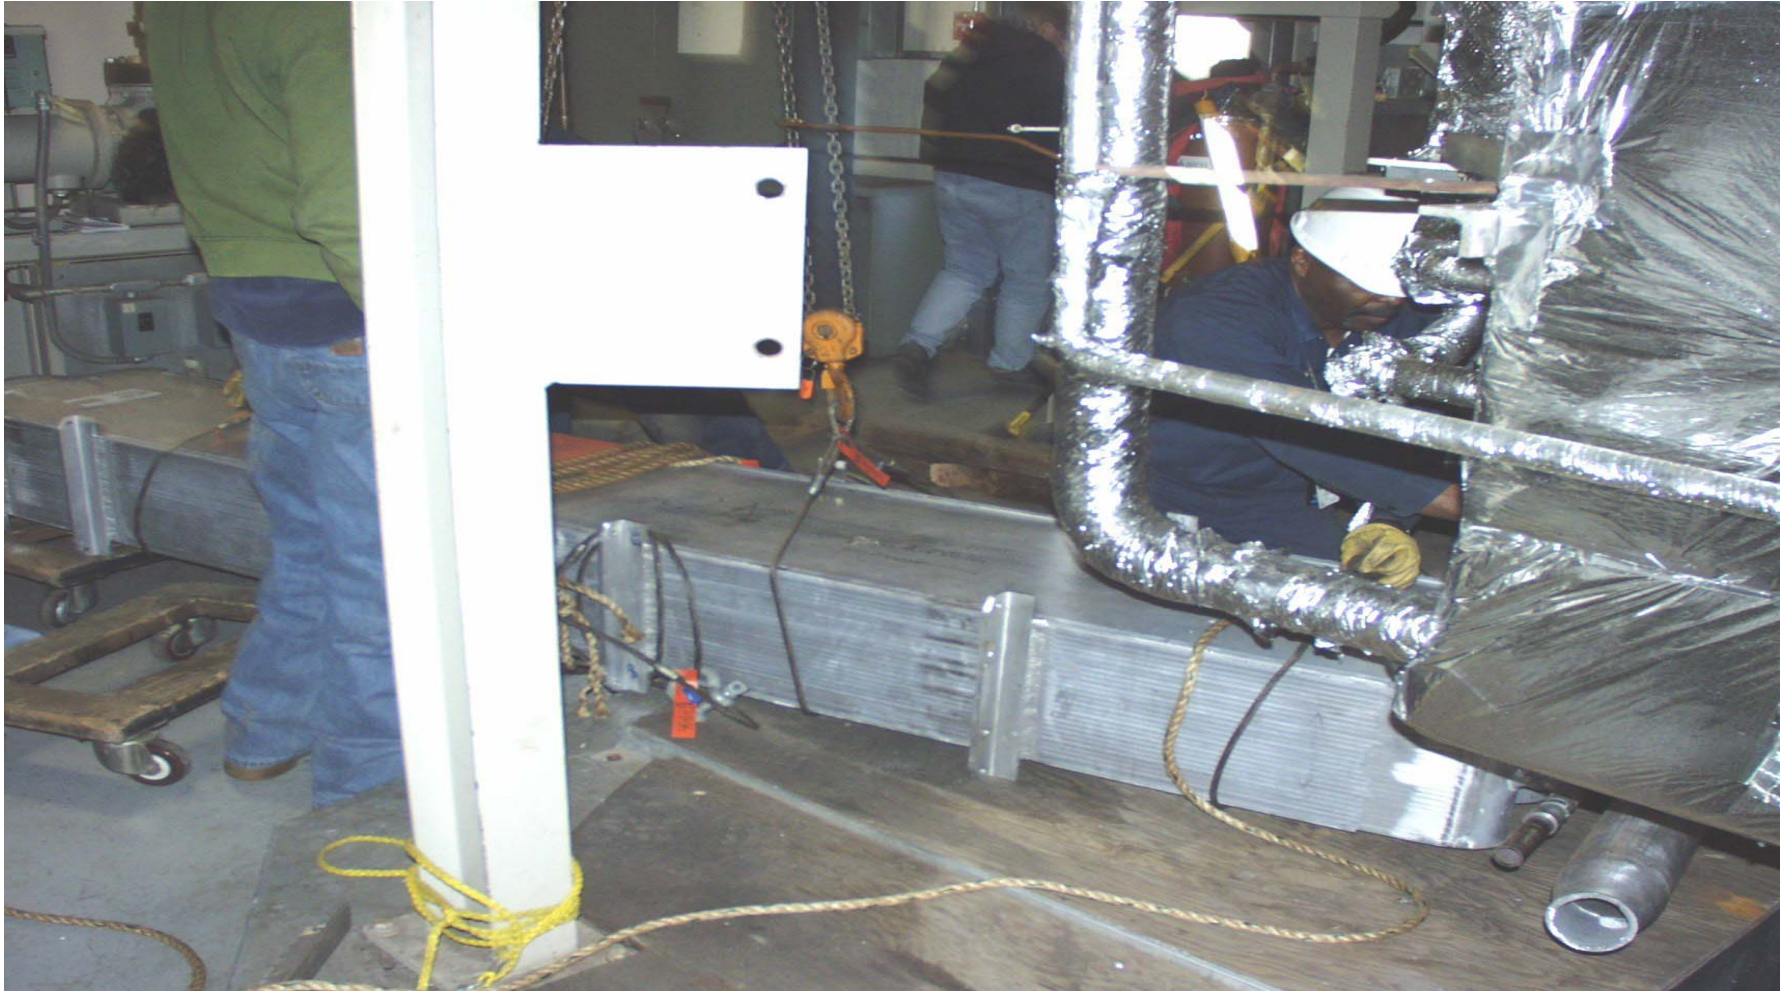
C.4) Heat Exchanger Removal Completed

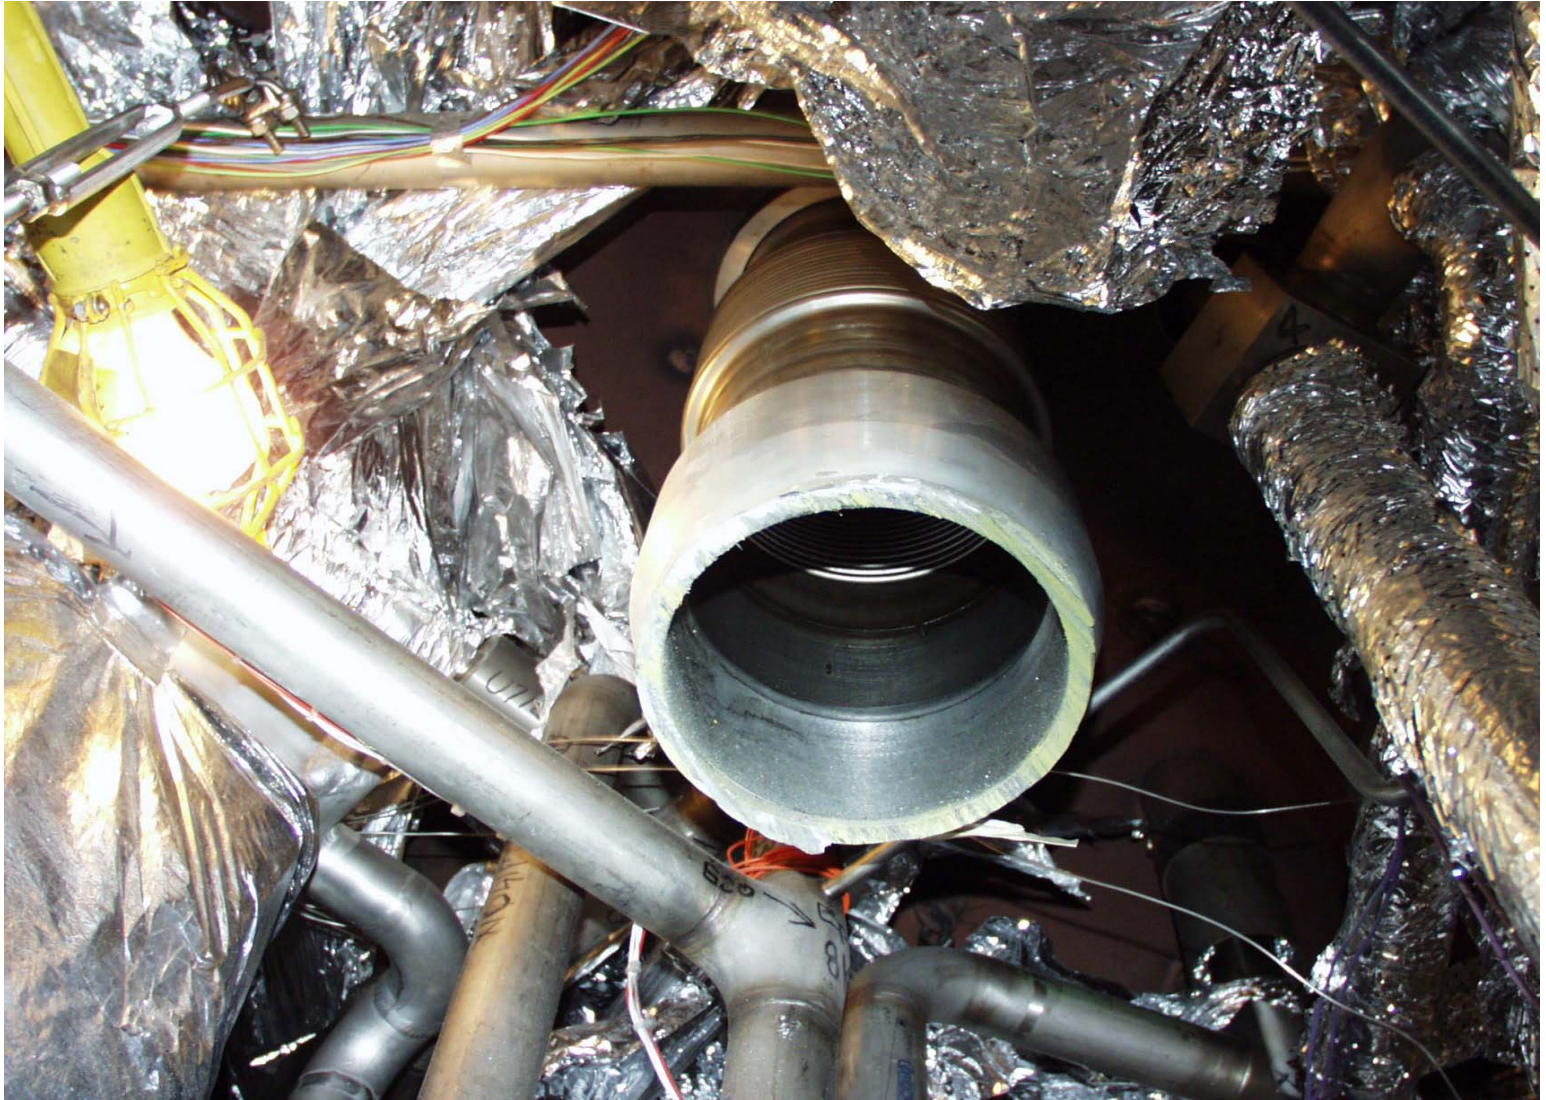
D.1) Pipe preparation (low pressure outlet.)
